NASA TN D-6690

INVESTIGATION OF AIRCRAFT TIRE DAMAGE  
RESULTING FROM TOUCHDOWN  
ON GROOVED RUNWAY SURFACES

*by Thomas A. Byrdsong, John Locke McCarty,  
and Thomas J. Yager*

*Langley Research Center  
Hampton, Va. 23365*

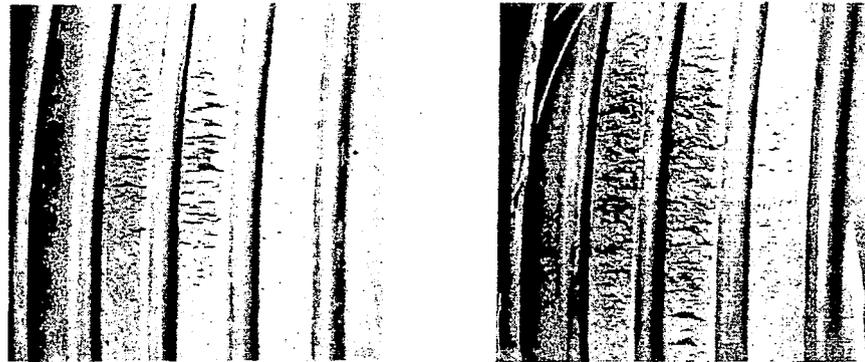
(a) Tire A.

Photographs which illustrate chevron-cutting tire tread damage are given in figure 5 for two of the test tires employed in this study. These photographs show the nature of the superficial cuts which can result from landing impacts on grooved runway surfaces. It was revealed from high-speed photographic coverage of the tires during touchdown that chevron cutting occurs at the spot on the tire which initially contacts the surface, and it appears that the damage is the result of the shearing action in the tire-pavement interface as the tire skids over the grooves. Chevron cutting was observed to cease when the tire begins to rotate. Thus, the larger and heavier the tire, the greater the inertia and the corresponding force necessary to induce rotation. This fact helps to explain why the smaller tires of fighter-type airplanes are not generally susceptible to chevron cutting.

$V_H = 91.1$  knots

$V_H = 110.5$  knots

Figure 5.- Chevron-cutting tread damage.

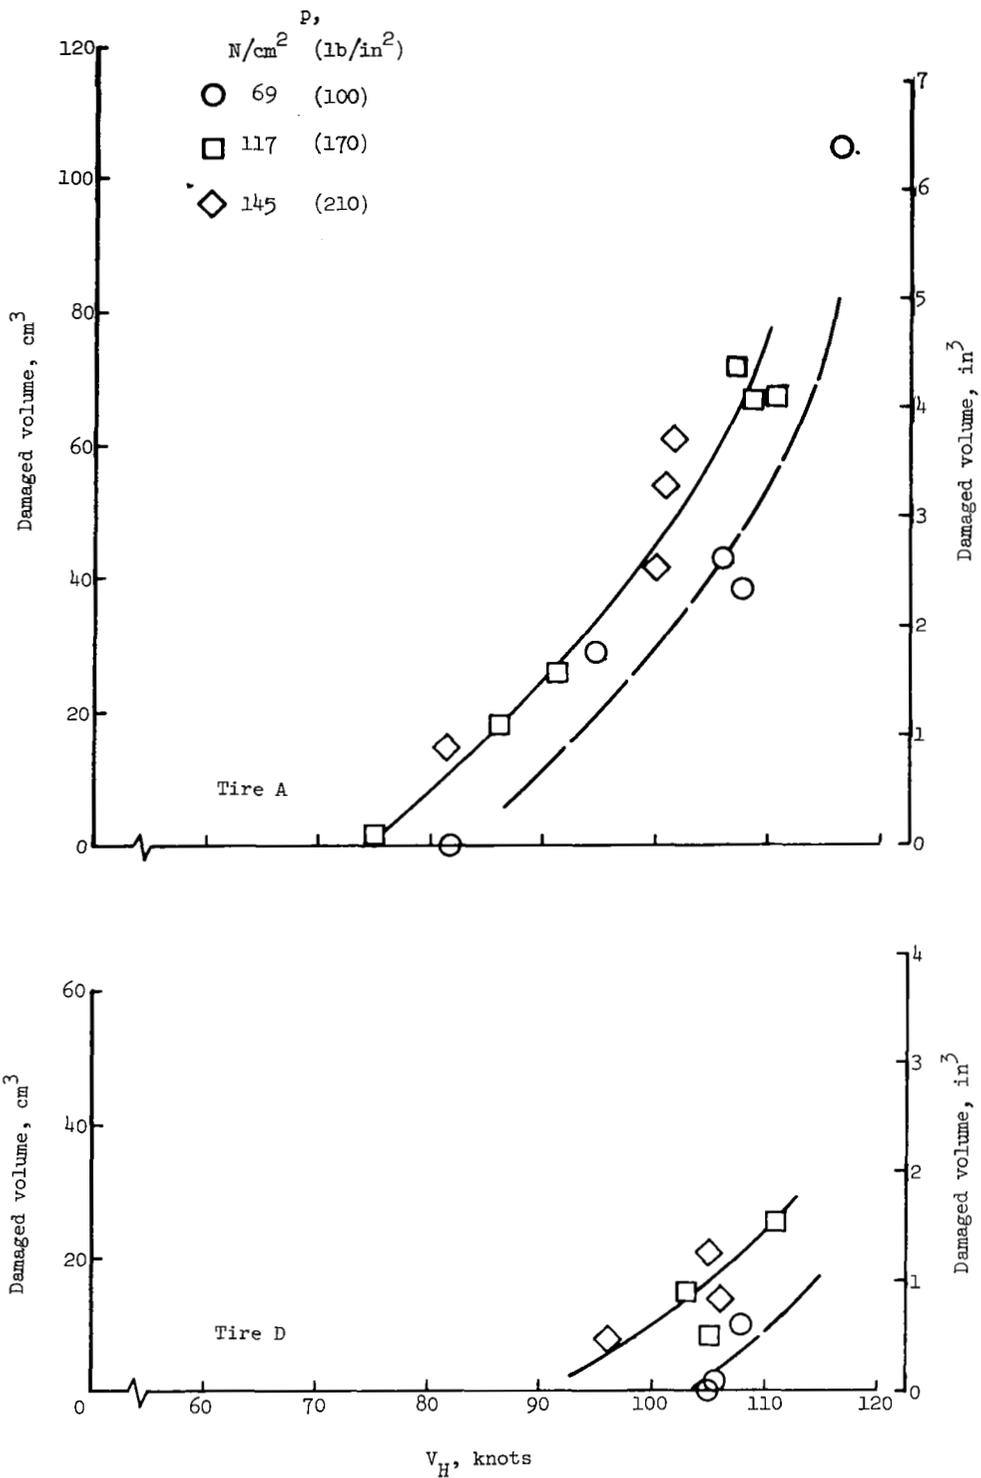
Inflation pressure. - The nominal tire inflation pressures for this study were 117 and 145 N/cm<sup>2</sup> (170 and 210 lb/in<sup>2</sup>); however, several additional tests were conducted on surface 7 with tires A and D underinflated at 69 N/cm<sup>2</sup> (100 lb/in<sup>2</sup>) to establish the effect of inflation pressure on chevron cutting. The results from these tests together with the results obtained at the nominal pressures are presented in figure 6, where the measured damaged volume is plotted as a function of the ground speed at touchdown. The scatter associated with the data in this figure and in subsequent figures for each inflation pressure may be attributed to possible inaccuracies in measurements of the damaged volume (particularly cut depths, which were more difficult to obtain) and to variations in each runway test surface resulting from the grooving process and from repeated touchdowns in the same area. The figure shows that differences in the damaged volumes associated with the two higher inflation pressures appear to fall within the scatter of the data such that the extent of tire damage is essentially independent of these two test pressures. However, the limited data at 69 N/cm<sup>2</sup> (100 lb/in<sup>2</sup>) do indicate that the tires are less susceptible to chevron cutting at low inflation pressures.

Figure 6.- Effect of tire inflation pressure on chevron-cutting damage. Surface 7.

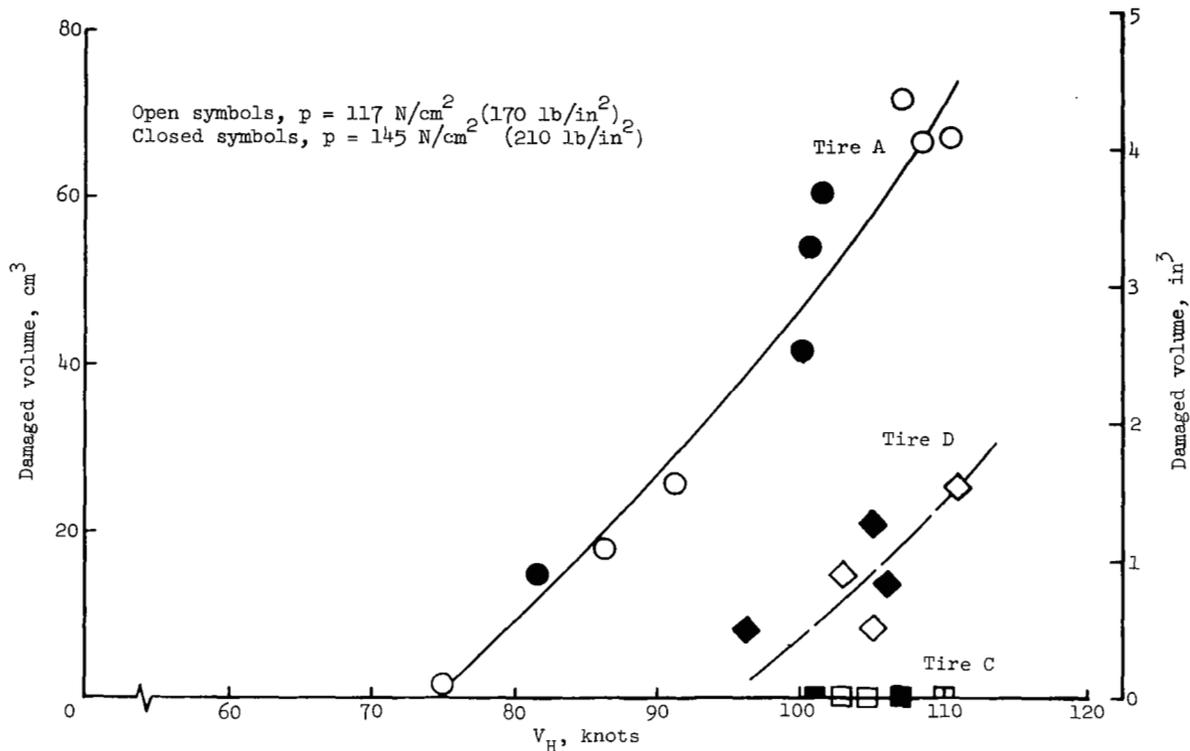
Figure 7.- Effect of tire differences on chevron-cutting damage. Surface 7.

cutting at touchdown velocities as low as 75 knots, that tire D was not susceptible to cutting below approximately 95 knots, and that tire C showed no evidence of chevron cutting up to the maximum test speed available with the facility. The data of this figure are for surface 7. The limited data for surfaces 1 and 2, as provided in table III, show similar trends for these tires.

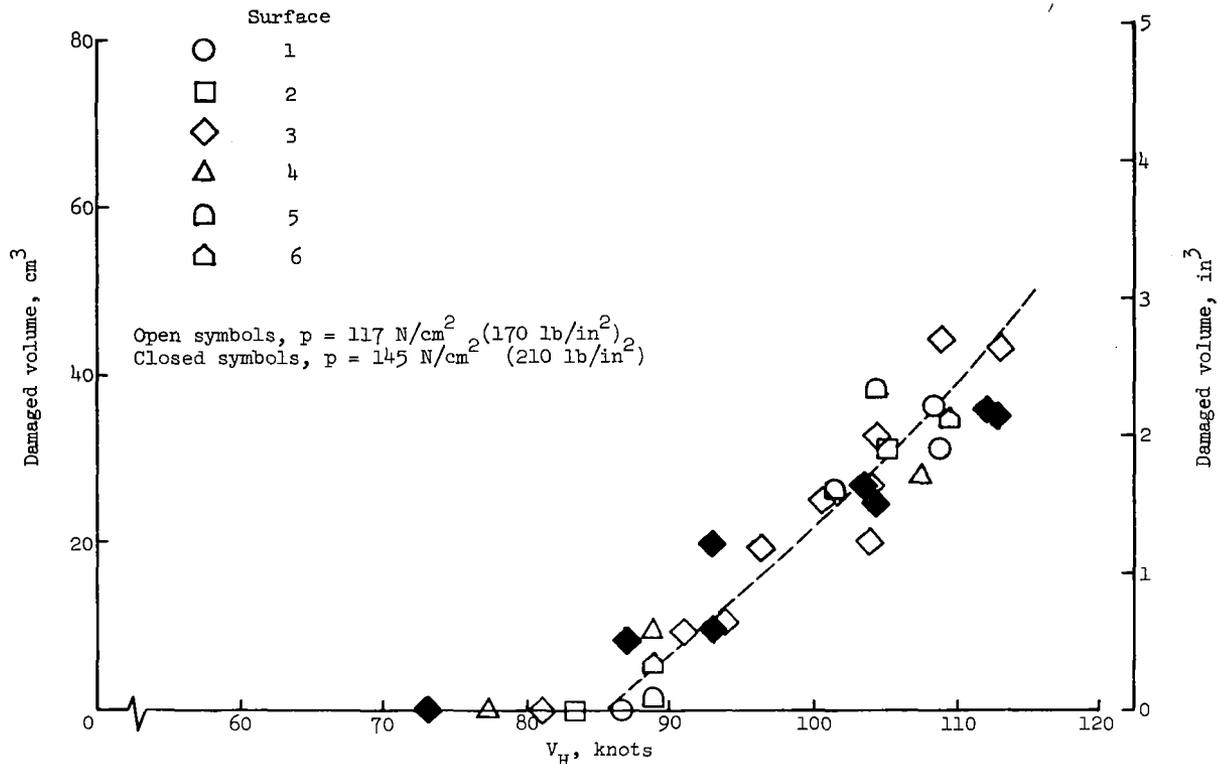
Grooving pattern. - Figure 8 summarizes the results of chevron-cutting damage as a function of ground speed for tire A on transverse-brush-finish concrete having groove patterns described by surfaces 1 to 6 in table II. Data are presented for tire inflation pressures of 117 and 145 N/cm<sup>2</sup> (170 and 210 lb/in<sup>2</sup>). The figure shows that the extent of chevron cutting is essentially independent of the grooving patterns tested, which included variations in the groove dimensions and configuration, in addition to the grooving technique. No chevron cutting was observed below approximately 85 knots on these surfaces, and, typical of all tire-surface combinations, the magnitude of the damaged volume is shown in the figure to increase with touchdown velocity and to be independent of the two inflation pressures within the scatter of the data.

Figure 8.- Effect of grooving pattern on chevron-cutting damage.  
 Tire A; brush-finish concrete.

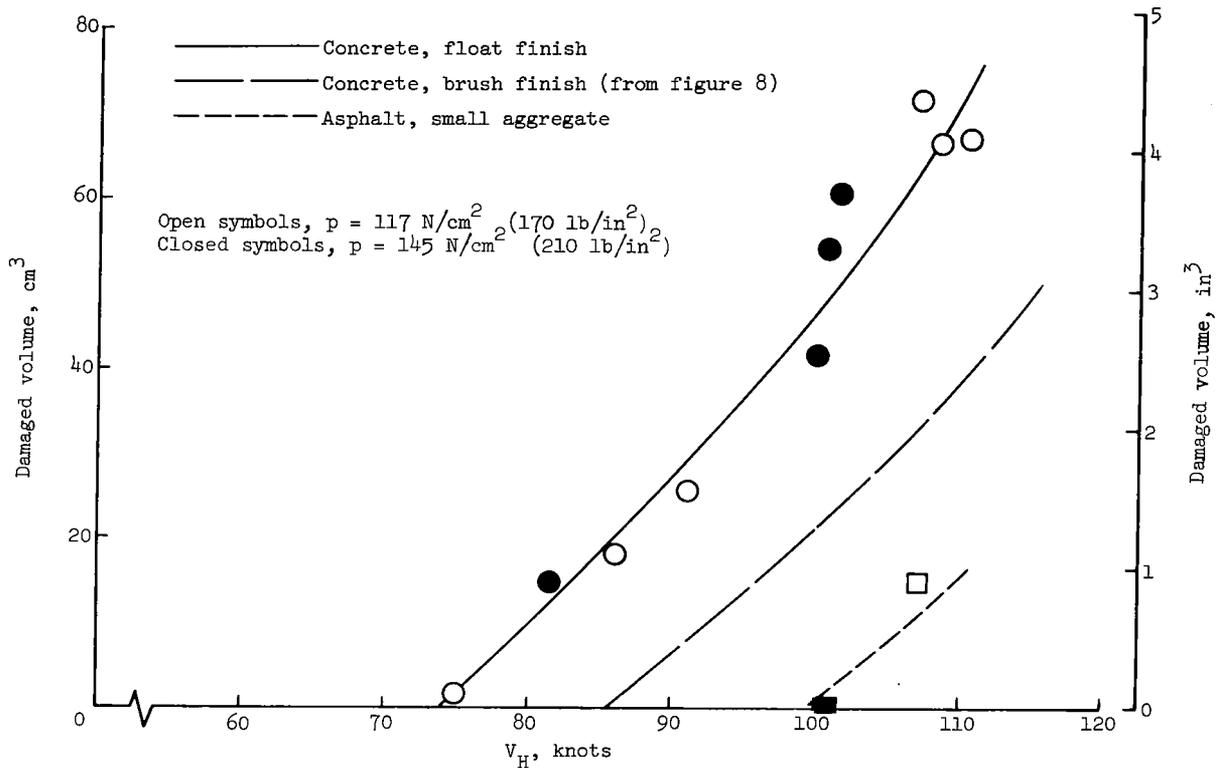
Surface finish. - The effect of surface finish on chevron cutting is illustrated in figure 9, which includes the results of tests, again obtained with tire A, conducted on the transverse-brush-finish concrete (surfaces 1 to 6), on the float-finish concrete (surface 7), and on the asphalt (surface 8). Presented in the figure are data for surfaces 7 and 8, which have the same grooving pattern, and the curve from figure 8 which fair the data for the brush-finish concrete surfaces having different patterns. The figure shows that the grooved transverse-brush-finish concrete is less damaging to the tire than the grooved float-finish concrete. The lower damage levels associated with the grooved brush-finish surfaces may be attributed to the edges of the grooves, which parallel the brush marks and hence are less distinct and more rounded than those in the float-finish concrete (fig. 2). This assumption helps to explain the even lower damage levels obtained on the grooved asphalt, which was observed (fig. 2) to have more rounded grooves than either of the concrete finishes. It should be pointed out that from the limited tests with tire D on surfaces 1, 2, and 7 (table III), the low damage levels associated with that tire show little distinction between the two concrete surface finishes. However, it does appear on the basis of the overall test results that tires are least susceptible to chevron cutting on asphalt surfaces, and a transverse brush finish for concrete surfaces would provide better tire wear, while possibly improving runway drainage.

Figure 9.- Effect of surface finish of grooved surface on chevron-cutting damage. Tire A.
